3M ESPE

Trouble

Shooting
Guide

Making Better Impressions

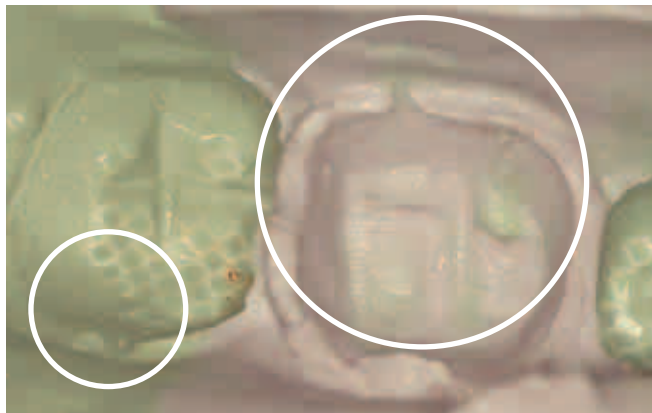
Void Caused by Syringe Technique

Visual Appearance: Voids/holes on margin of the prepared teeth. Incomplete margin.

Result: The fit and function of the final restoration may be compromised. Short crown margins and/or open margins.

CAUSE	SOLUTION
Air trapped in intraoral syringe.	Properly bleed filled elastomer syringe. Keep tip immersed in material when loading syringe. Do not stop when in the middle of loading syringe.
Air trapped while filling impression tray.	Keep mix tip immersed in tray material while filling the tray.
Improper syringe technique.	Keep syringe tip immersed in wash material to avoid entrapping air. Wiggle and stir while syringing. Push material forward.
Inadequate coverage of marginal area with light body impression material.	Use wash material liberally on preparation and abutments.

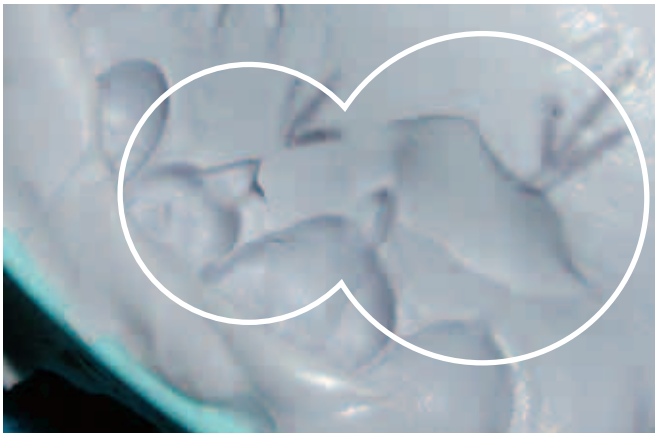
Trapped Air or Moisture

Blood and saliva contamination around prep.

Use good moisture control technique. Rinse and dry prep area before taking the impression.

Stop bleeding by using appropriate retraction technique and hemostatic agent. Leave cord in sulcus until no blood or saliva are present before syringing the light body impression material. Consider two-cord retraction to displace tissue and control fluids.

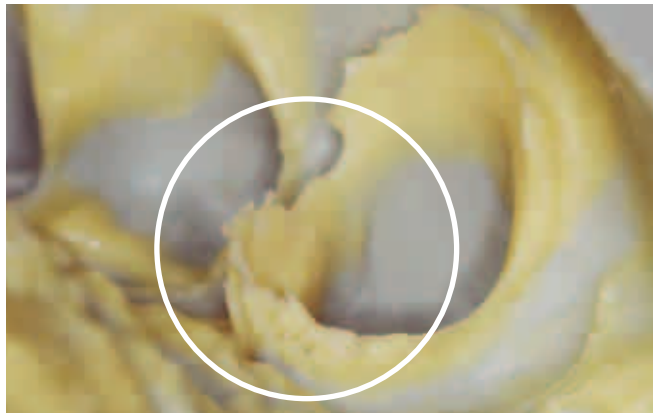
Poor Retraction — Insufficient Tear Resistance

Visual Appearance: Rip, or visible tearing on the margin of the preparation.

Result: Short crown margins and/or open margins.

CAUSE	SOLUTION
Expired impression material.	Check expiration date of impression material.
Inadequate mix.	Bleed before applying mix tip to ensure even dispensing. Use proper mix tip. Ensure mixing instructions are followed and materials have a streak-free appearance.
Insufficient retraction.	Displace tissue to allow the impression material to access prepared area. Consider two-cord retraction. Leave pilot cord in the sulcus when taking the impression. Use impression material with sufficient tear resistance.
