3M ESPE

Trouble

Shooting
Guide

Making Better Impressions

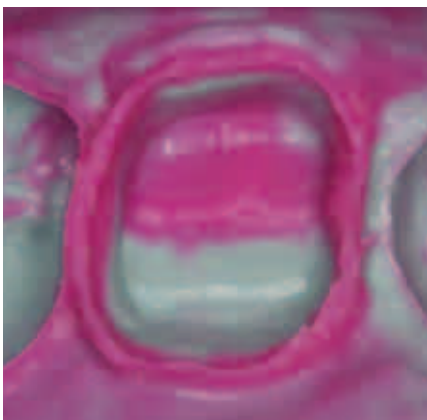
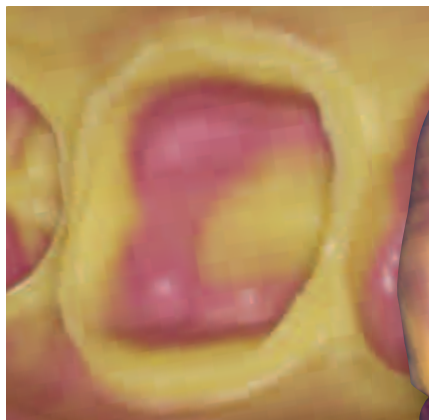
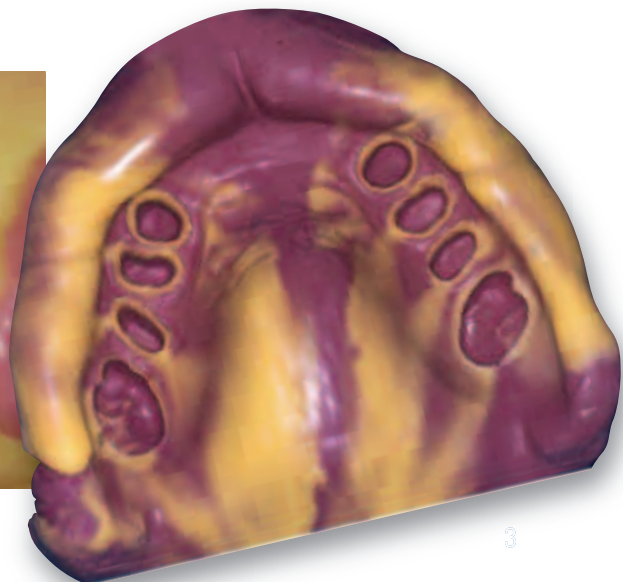
Inhibited or Slow Setting

Visual Appearance: Impression not completely set. Shiny, no detail of site.

Result: Inadequate surface detail on stone cast, poor fitting restorations.

Sulfur inhibition due to contact of latex gloves with tissue/tooth/retraction material or impression material.

Residues from custom temporary or provisional cements (acrylics) present.

Wear gloves proven not to contain traces of sulfur.

If contamination is suspected, scrub affected area with diluted hydrogen peroxide.

Do not use impressions already used to fabricate the temporary restoration.

Fabricate the temporary crown or bridge after final impression has been made.
